**VISUAL ASSESSMENTS OF CURRENT PAVEMENT CONDITIONS IN THE STACK
AREAS OF BERTH 203-205 AT THE DURBAN CONTAINER TERMINAL – PIER 2**

Rowen Naicker and Dhiren Allopi

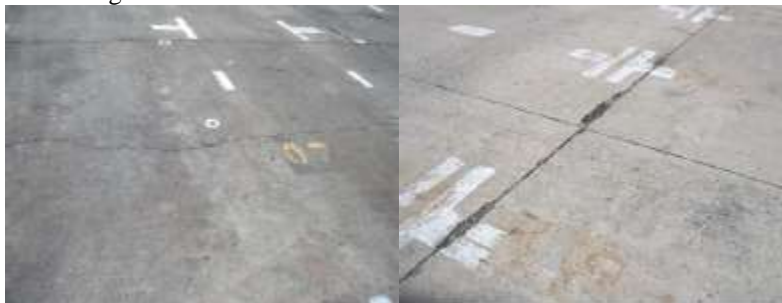
GOOD: No visible cracks or cracks less than 2 mm aperture. No, or minor spalling along panel edges not affecting the riding surface. Joint seal in good condition.

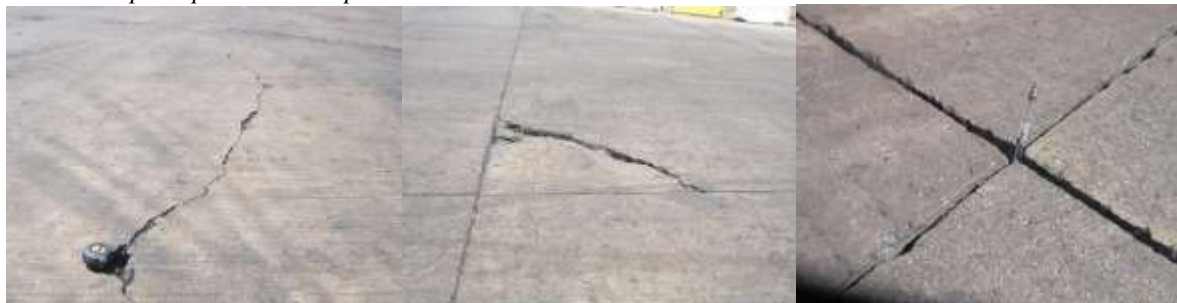
FAIR: Cracks with aperture between 2 and 10 mm. Spalling along panel edges to a depth in the order of 50 to 100 mm resulting in a locally uneven riding surface. Joint seal either damage or non-existent. *Condition suggests localised repairs/partial slab replacement and/or routine maintenance.*

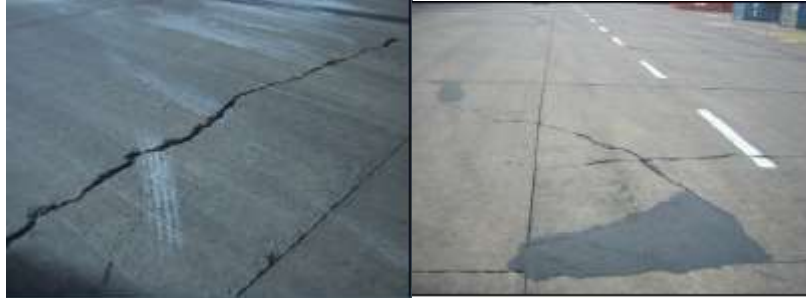
POOR: Cracks with aperture greater than 10 mm and panels with a general appearance of being completely broken into independent pieces (shattered slabs). Spalling to a depth greater than 100 mm. *Condition suggests slab replacement.*

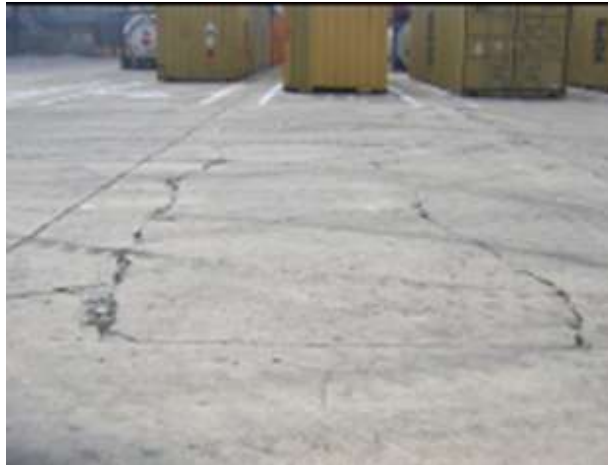
- 1) Some of the pavement in the paths used by the straddle carriers were cracked and showed signs of differential vertical movement between concrete on either side of the cracks

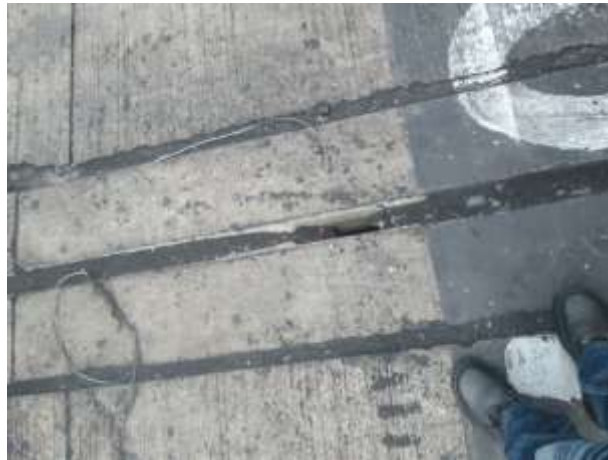
- 2) Slot drains were filled with debris, thus not allowing proper drainage through slot drains

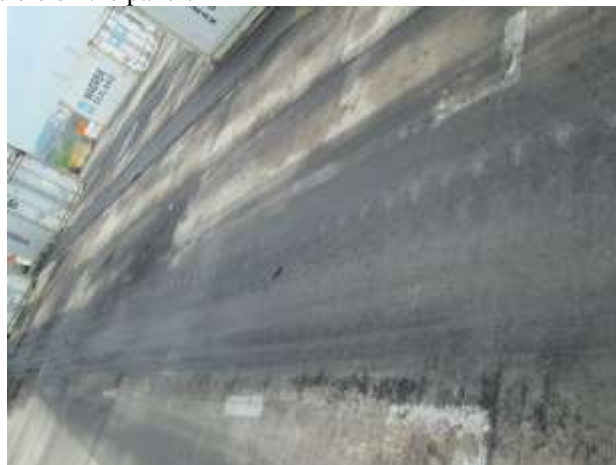
- 3) Comments made by straddle carrier drivers met on site indicated that the cracks had reached a stage where it detrimentally affected the riding quality
- 4) Most concrete pavement panels in the terminal were not cleaned and the presence of thick grease from the straddle carriers were visible on the panels

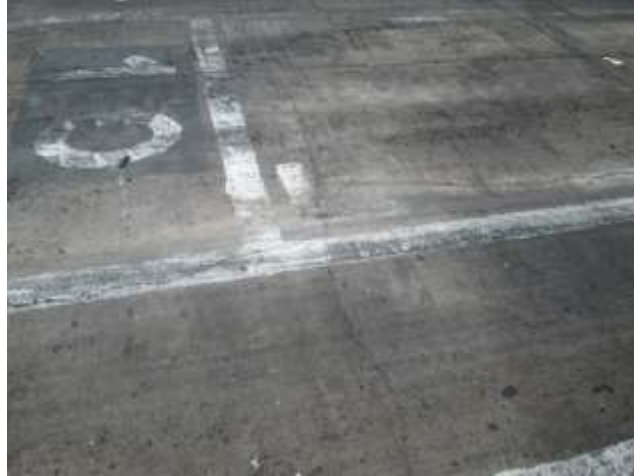
- 5) Signs of spalling at the corners where the joint meets,
- 6) Extensive shrinkage cracks
